PERONA LAKE DAM NO.2
NJ 00294

6 PHASE 1 INSPECTION REPORT
NATIONAL DAM SAFETY PROGRAM.

PERONA LAKE DAM NO. 2 (NJ00294)

Name of Dam Perona Lake Dam No. 2 FED ID# NJ 00294
NJ ID #144

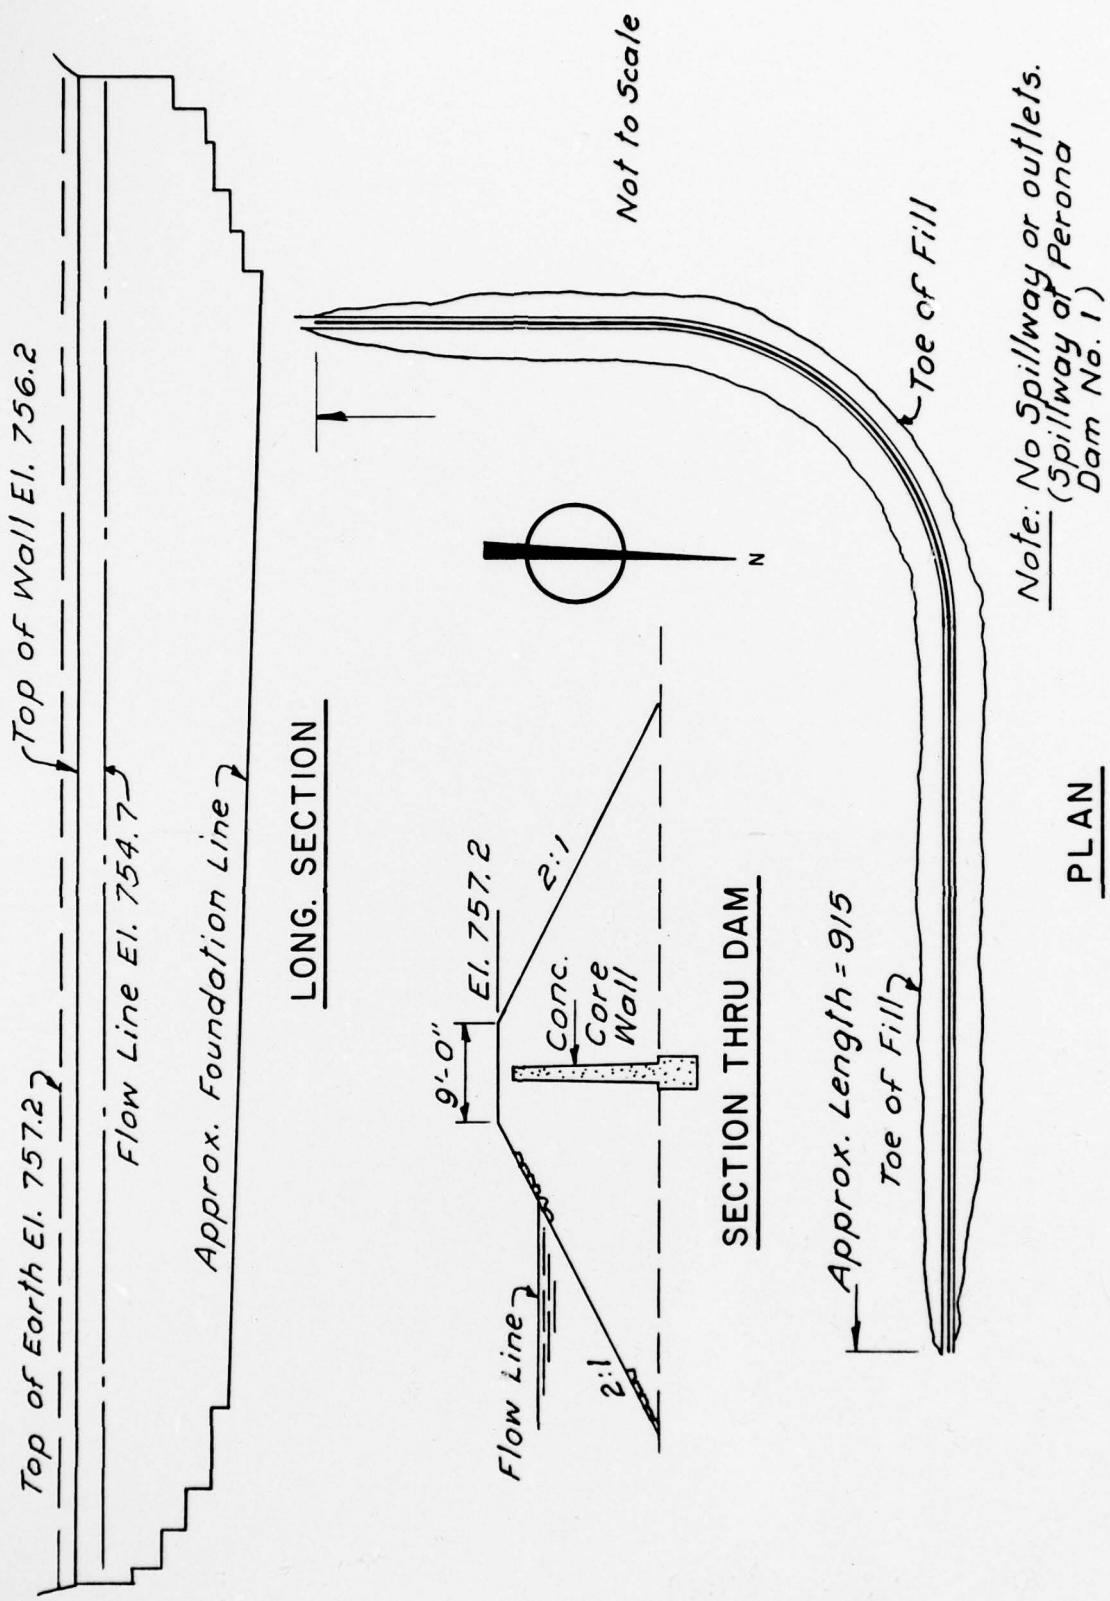
DETAILS OF DAM NO. 2
FIGURE 3

The only design information located for review were the two drawings prepared by Snook and Hardin which were filed with Dam Application 144 in 1929. These depicted the details of Dam No. 2 which is essentially an earth dike which proved necessary to construct at the time to fully contain the man-made lake. The full length concrete core wall is somewhat of an excessively conservative feature of the design in view of the height of embankment but followed the design standards adopted for Perona Dam No. 1 which is considerably taller. No design computations were available.
